Manhole Inspection Summary

Manhole # S17I__004MH

Insp Date: **2/27/08 11:41 AM**

Location Address: **2500 lombard st**

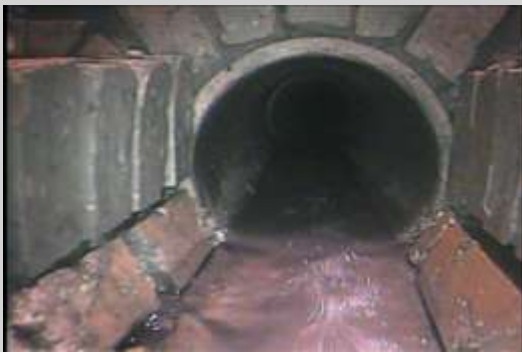
12 O'Clock Outflow

8 in. Circular Gravity Sewer
Pipe Out @ 12 O'Clock

Pipe Height: **8.4** (in.) Rod and Bar (Angled)
Pipe Material: **Clay** ☐ Pipe Lined
Invert Depth: **10.34** (ft.) Flow Characteristics: **Slow**
Deposits: ☒ None ☐ Mud ☐ Sludge ☐ Debris ☐ Grease
Silt Depth: **0** (in.) Deposits Extent:
Infiltration: **None** Pipe Seal Cond: **Sound**
